WING LEADING EDGE FUEL TANK IMPACT TESTS

Report No. FAA-RD-72-83

FINAL REPORT

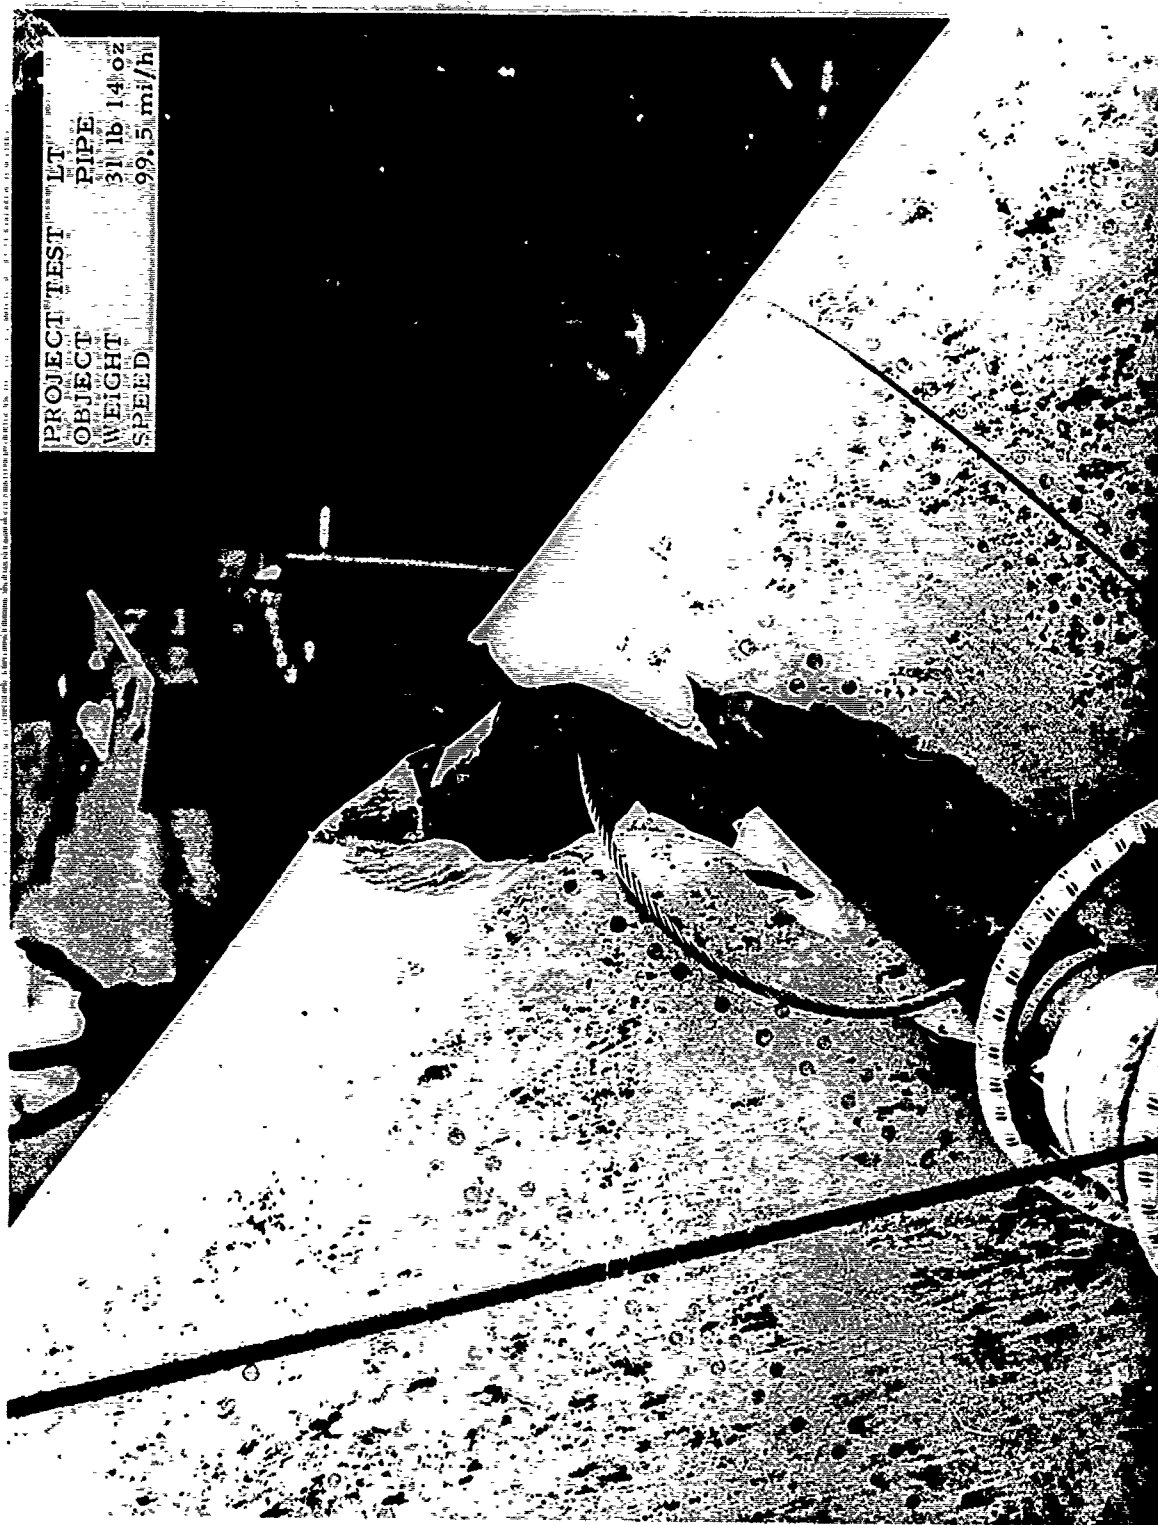
FIGURE 8: DAMAGE TO WING - TEST 3, 99.5 MI/H - PIPE

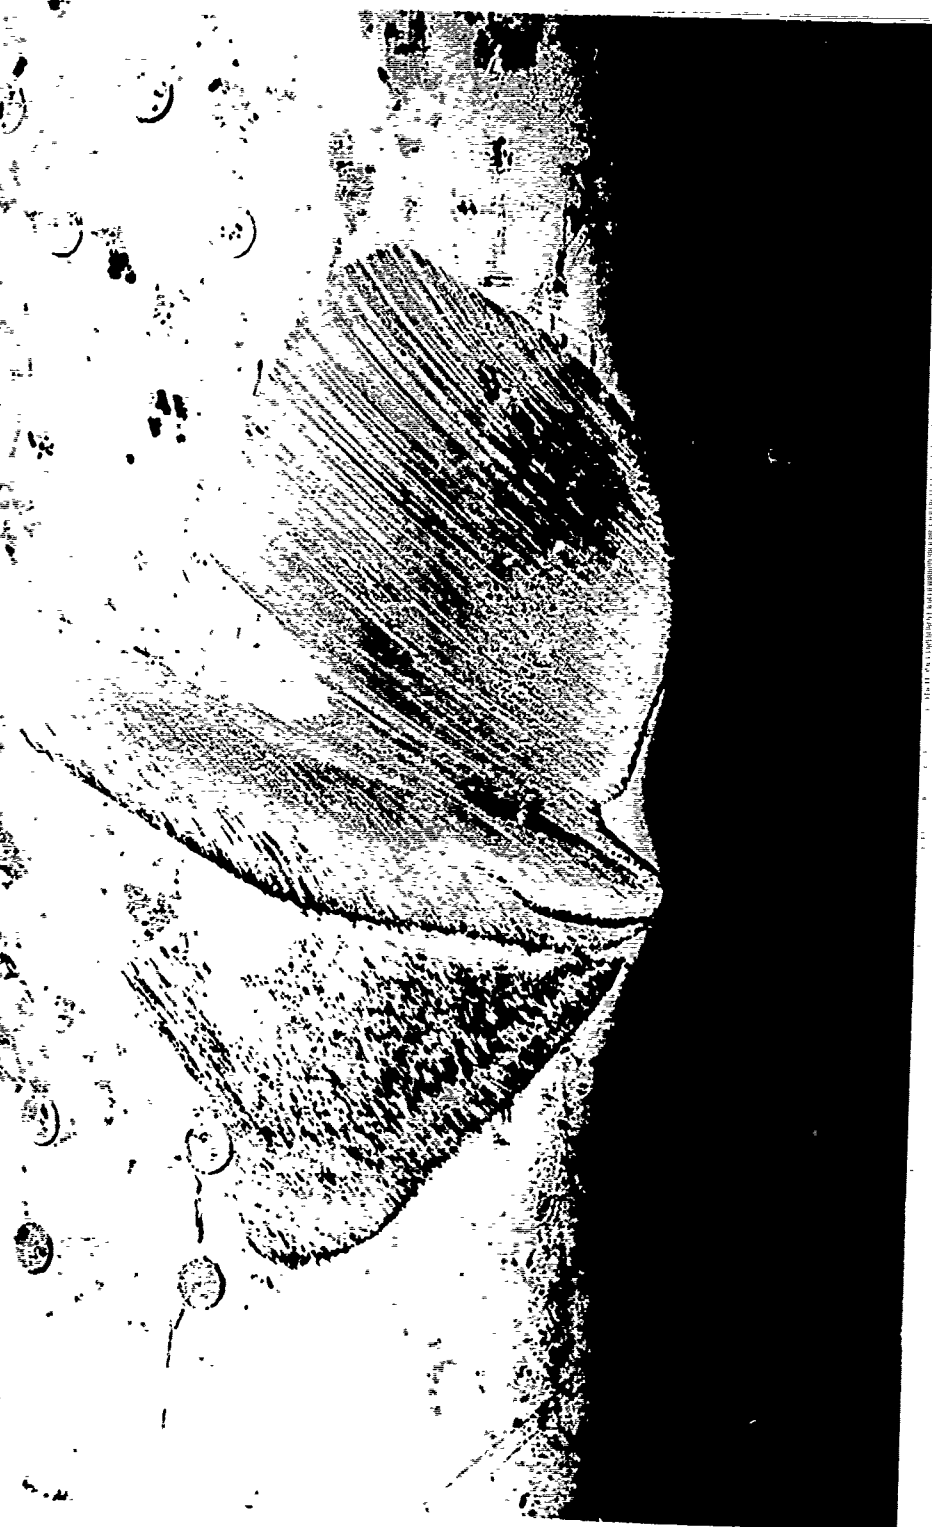
PROJECT TEST LX
DROP TOWER
TEST NO. 61
OBJECT ANGLE IRON
WEIGHT 26 lb 10 oz
SPEED 73.7 mi/h

FIGURE 13. DAMAGE TO WING - TEST 7, 73.7 MI/H - ANGLE IRON
